**Canadian Society of Civil Engineers,**

**NOTES ON RETAINING WALLS IN MONTREAL.**

By H. IRWIN, M.CAN.SOC. C.E.

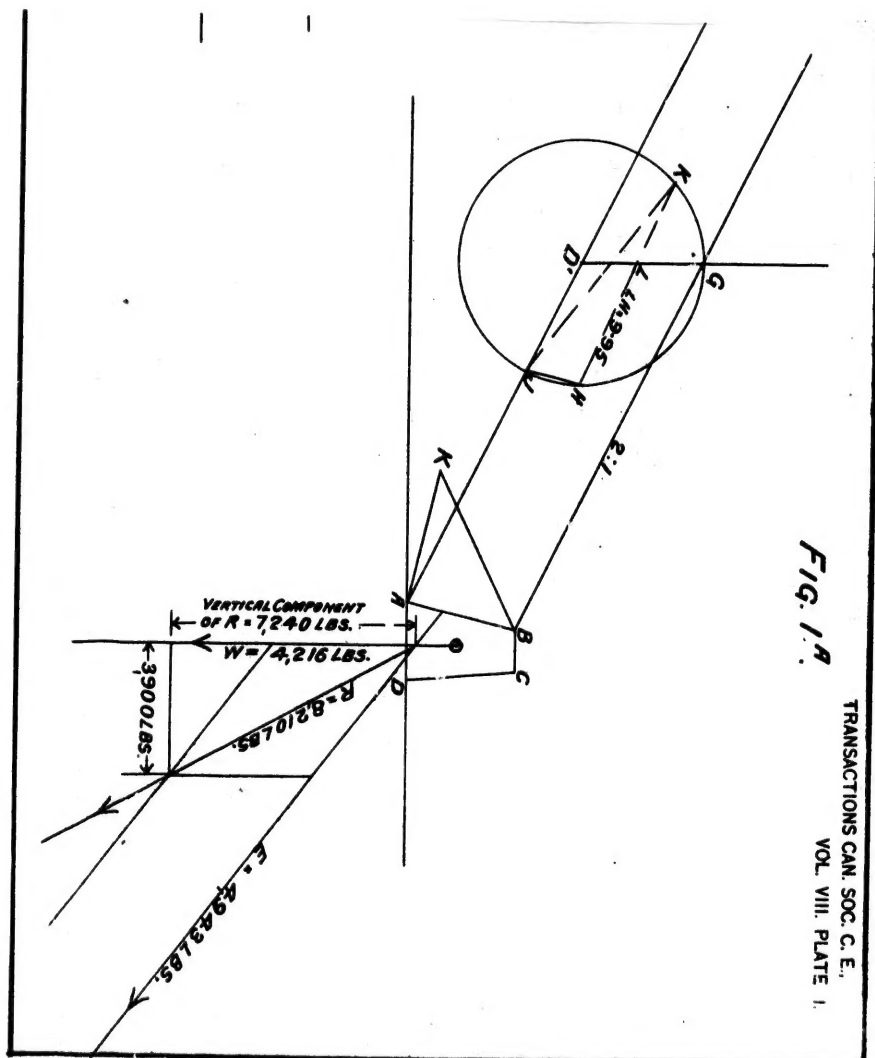
FIG. 1.

The wall shown in section by Fig. 1 is of dry masonry, built of stones from three feet to eight feet in length, by from ten inches to fourteen inches thick, the beds of the stones being fairly flat, but the back of the wall, in some places, seems to be rather poor, the stones being too small; the top front course was built with large, flat stones from five feet to eight feet six inches in length, but the writer has not been able to find out what proportion of through stones were used. The filling behind the wall is principally clay, a small proportion being earth and sandy clay, and was dumped from cars running on a temporary trestle.

The bank on which the filling rests has an average slope of about  $2\frac{1}{2}$  to 1, and was not benched before the filling was begun; at the temporary trestle must have largely helped to keep the embankment from sliding, as it was built for a double track and was well braced longitudinally.

The bank under the filling is of gravel, which absorbs the melting snow in the spring very quickly, so much so that the catchwater ditch on the upper side of the slope seldom has any water in it, and there is never any sign of water passing down between the original slope and the clay filling.

The wall at the foot of the slope was built with a face batter of 1 in 12, the batter of the back being 1 in 4; and shortly after the filling was finished it pushed the wall gradually forward till the top overhung the base by about 1 in 12, the embankment rising behind the wall.

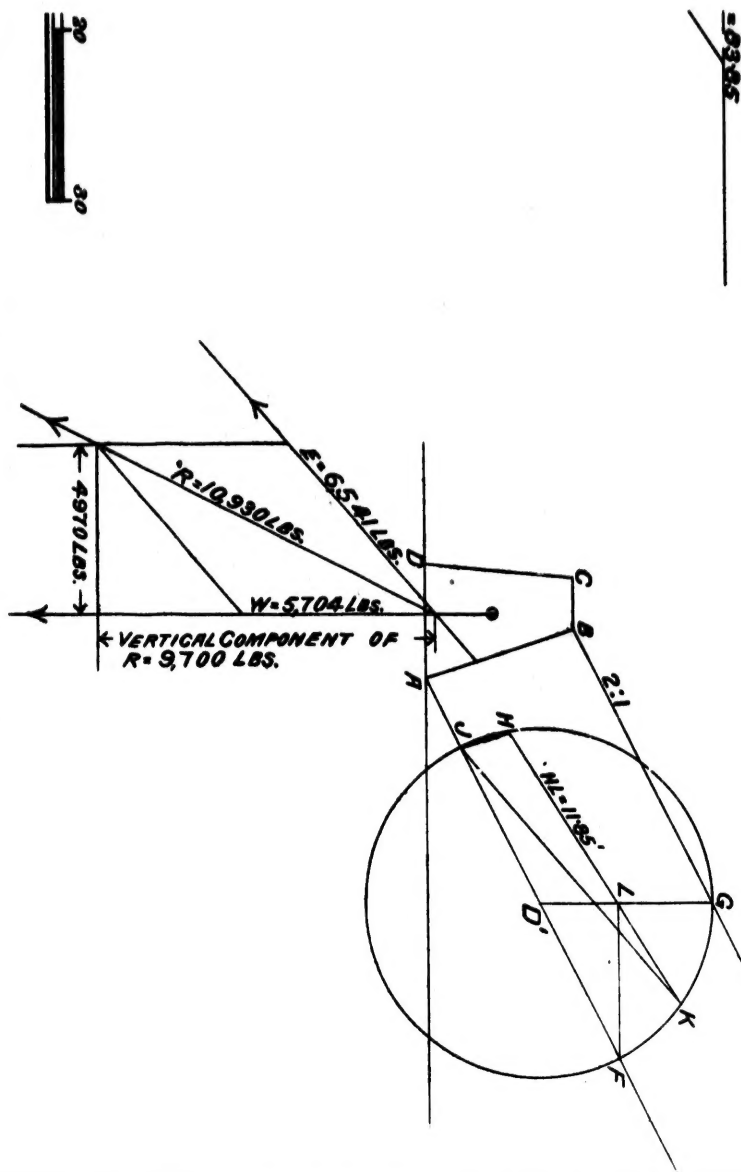
Fig. 3<sup>a</sup>

The diagram 3 A shows that, if the wall had been built according to Trautwine's dimensions, it should have had, by Weyrauch's theory, a factor of safety of one and a half against the stones sliding on the course above mentioned as being eight feet nine inches below the top of the wall; but this theory makes no allowance for vibration caused by trains.

Diagram 3 A is drawn for the wall as it was actually built and for the course above mentioned.

As the wall was made with extra large stones, its weight is taken at 0.82 of solid stone, or 135 lbs. per cubic foot, the clay filling being taken at 120 lbs. per cubic foot, and being assumed to come only to the top inner corner of the wall.

The diagram shows that the horizontal component of the thrust is 4,970 lbs. per foot run of the wall, and that the vertical component of the resultant pressure is 9,700 lbs., which, divided by 2 to get the frictional resistance to sliding, gives 4,850 lbs. for this resistance, therefore, according to the theory mentioned above, the stones at this point should have been just about ready to slide without the help of vibration.

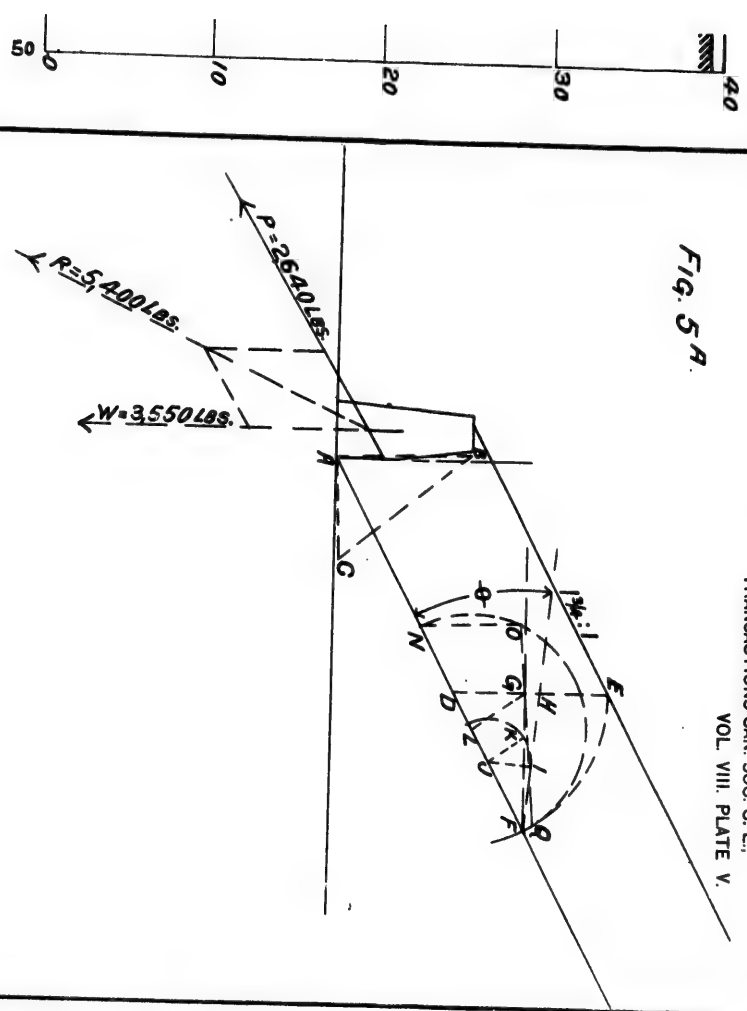
Fig. 5 shows the old retaining wall on Seigneurs street between St. Antoine street and Dorchester street, where it runs diagonally up the face of the hill.

The dimensions were taken by the writer while the wall was being taken down a short time ago, and seem rather too small considering the amount of surcharge, yet its partial failure seems to have been due to the want of proper care. Had the joints been all well raked out and filled with good cement mortar, it would doubtless have stood as long as it was wanted.

When the old wall was removed and the bank cut back, its face stood perfectly well at a slope of about  $\frac{1}{4}$  to 1, apparently almost vertical, the material of the bank being mostly compact fine gravel and sand, which would stand at a very steep slope so long as it was undisturbed and protected from the weather; in fact, it looked firm enough to require a very thin wall if proper precautions were taken to prevent water from lodging behind it, and if the filling replaced at the back of the wall were well rammed so as to prevent any movement of the old bank behind.

According to Trautwine, a rubble masonry wall with a surcharge similar to that shown in Fig. 5, and with the given batter, should be 5 feet 5 inches thick at the ground line and 3 feet 9 inches at the top, instead of 3 feet 3 inches at the base and 2 feet at the top; however, it must be borne in mind that Trautwine's dimensions are given for a bank of clean dry sand which would exert far more pressure than the bank in question, the surface of which above and behind the wall was covered with the old sod and bound together with the roots of trees, and the material of the bank was, as already stated, very compact.

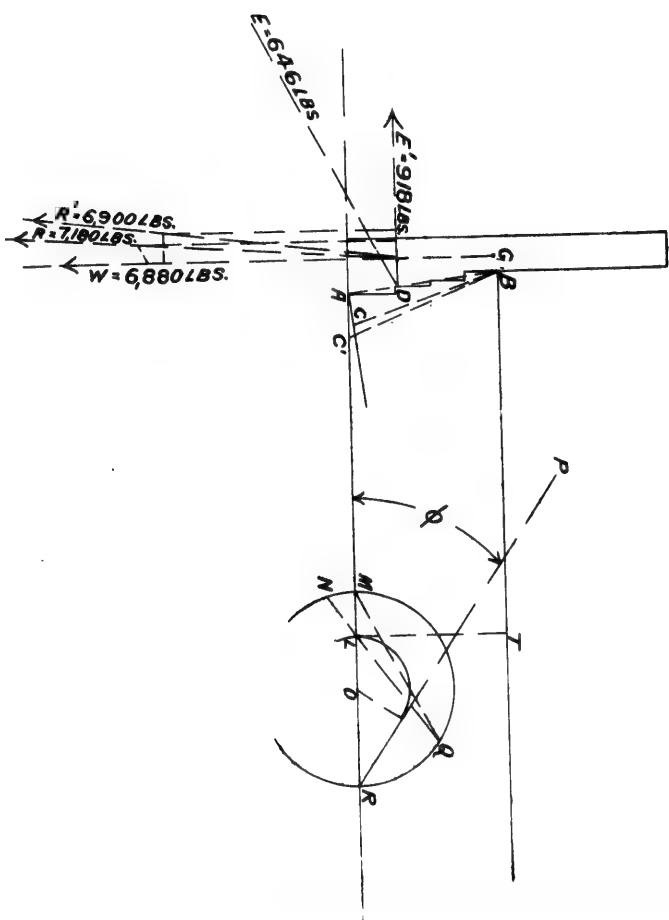
**FIG. 7A.**

The diagram down in Fig. 7A, drawn according to Weyrauch's theory, shows that the wall would be in no danger of overturning and that the courses would not slide on each other.

In drawing this, the masonry was taken at 160 lbs. per cubic foot and the loose earth at 80 lbs. per cubic foot.

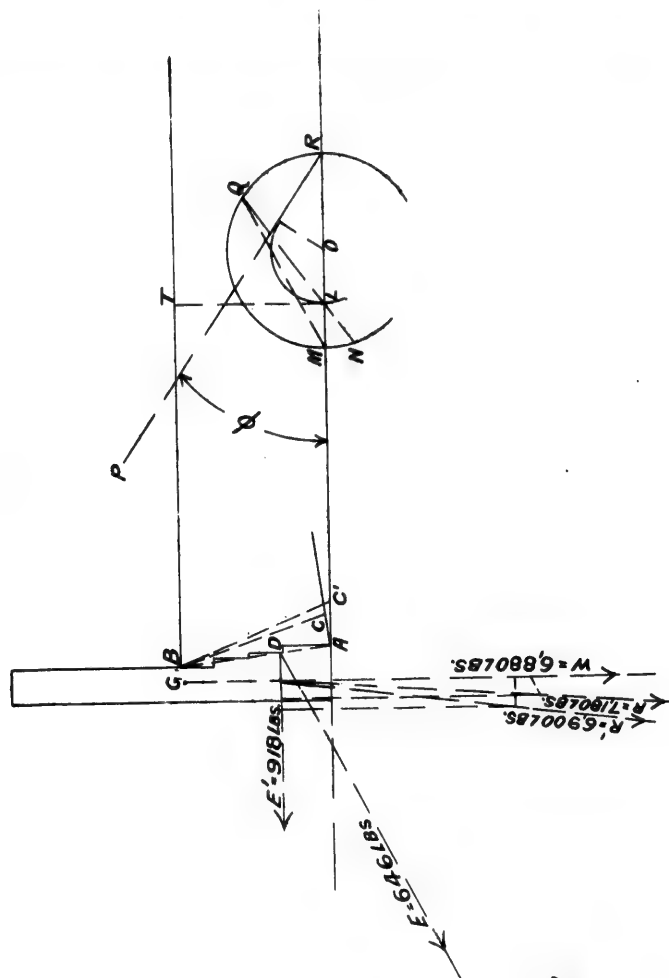
**Fig. 7.**

Fig. 7 is a section of the wall on the west side of Bleury street and just above Dorchester street.

It failed by bulging out on the face, and was taken down and rebuilt last year.

It will be seen that the wall was about thick enough to retain the filling, for 8' 9" multiplied by 0.4 gives 3' 6" for the thickness at grounds level, while the actual thickness of the wall was 3' 3", and the vertical pressure of the extra 10 feet in height would have been more than enough to ensure the stability of the wall, providing it were properly built.

In fact, the wall bulged out in one place where there was no filling, at all behind it.

The greatest bulge was at a height of 6 or 8 feet above the level of the sidewalk, or almost as high as the top of the filling, and this seems too high to have been caused by the lateral pressure, since the greatest bulge should be about the centre of pressure.

The failure seems to have been due entirely to bad mortar, want of proper headers, and through stones and excess of mortar in the backing.

The writer examined the wall carefully after it had been almost all taken down, and could find no trace of a through stone or of a good header at all, and the wall seemed to have parted in two, the cut stone front separating from the backing.

The face was built of cut stone with a bed of only about 8 inches in depth, and the backing was of small stone with altogether too much mortar in the joints. The mortar was made of very fine dirty sand with too little lime in it, and what little there was no doubt of the useless fat lime now exclusively used in Montreal, because it is cheaper than good lime made from the black limestone which takes more fuel to burn it.

The consequence was that the upper 10 feet of the wall compressed the mortar in the backing, while the cut stone front, with its thin joints, would scarcely compress at all, and the front was forced out.

The writer believes that this wall would have stood perfectly well if a sufficient number of headers and through stones had been used, and if the mortar had been made of good cement and sand, in accordance with the specification; but thinks that it would have been better to have arranged to set the upper 2 foot portion 4 inches back from the face of the part below.
